Schedule B1 and Schedule B2 Asbestos

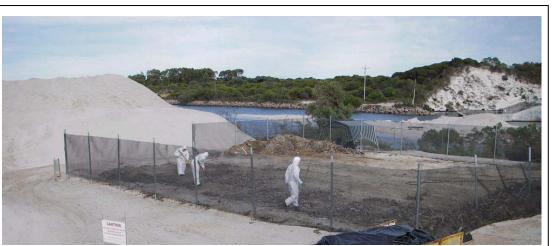
Raking of surface soils to remove ACM fragments

After remediation the exposed surface of the site under assessment should be free of visible ACM fragments and all ACM should be removed from the top 10 cm of soil as far as practicable. Alternatively a 30cm layer of topsoil can be layered over the site.
